Notification No	/	Report No	/
Date of Notification	2021.June.28	Date of Inspection	2021.July.1,2,3

4. Description of Goods (As per PO/Contract/LC/other References)			
Item	Description	Quantity	Pcs
1	*** Regeneration Gas Compressor of product no ***/***	2	Set
2	*** C2+ Regeneration Gas Compressor of product no ***/***	2	Set

10. Inspection Description			
Base on IDR no. ***, ITP(***&***), inspector was present at inspection on July 1,2,3, 2021, the results were found as below:			
<ul style="list-style-type: none"> • D5.1Material Inspection for Piping on Regeneration Gas Compressor Tag No. *** • D5.1 Material Inspection for Piping on C2+ Regeneration Gas Compressor Tag No. *** • D5.2 NDT for Piping on Regeneration Gas Compressor Tag No. *** • D5.2 NDT for Piping on C2+Regeneration Gas Compressor Tag No. *** • D5.3 Hydrostatic Pressure test for Piping on C2+ Regeneration Gas Compressor Tag No. *** • D6.4Visual and dimension check for Oil filter on Regeneration Gas Compressor Tag No. *** • D6.4Visual and dimension check for Oil filter on C2+Regeneration Gas Compressor Tag No. *** • B7.1 Clearance recheck for seals, bearings and impeller on Regeneration Gas Compressor Tag No. *** • B7.

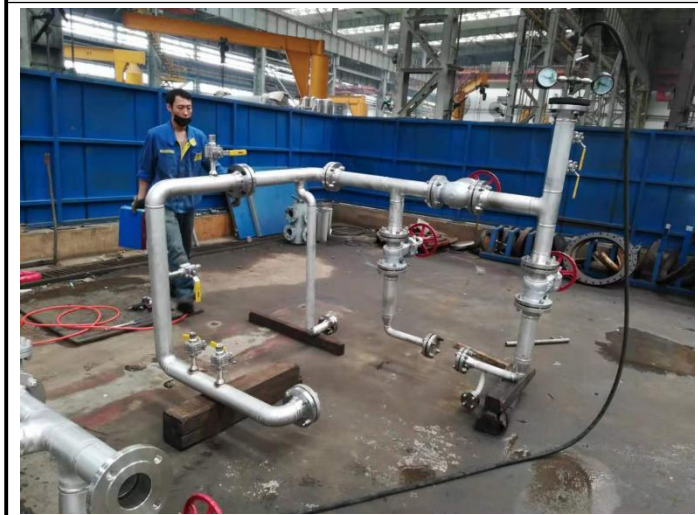
Results: No leakage and abnormal sound. The result was acceptable with notes. Details refer to Att-03 *** piping's Hydrostatic test reports.

1. The hydrostatic pressure test for piping of Regeneration Gas Compressor of product no ***

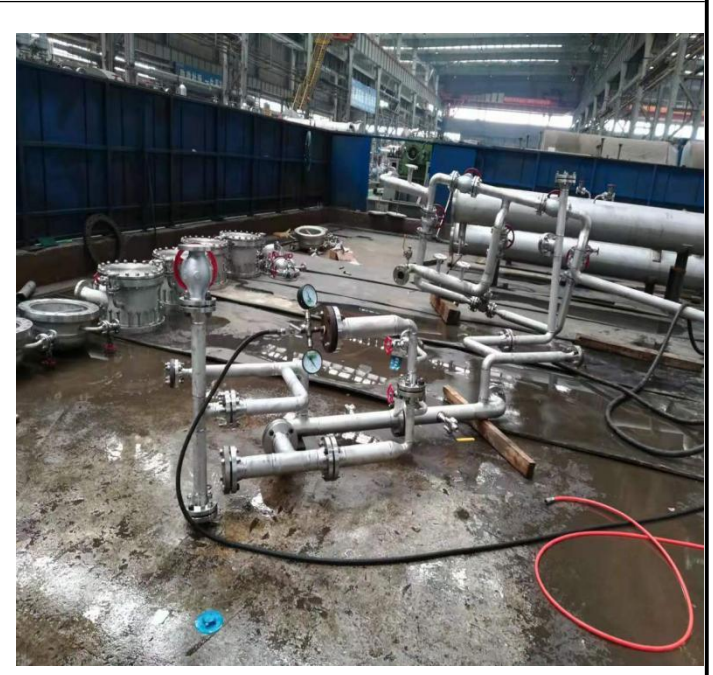
4. The hydrostatic pressure test for piping of Regeneration Gas Compressor of product no ***

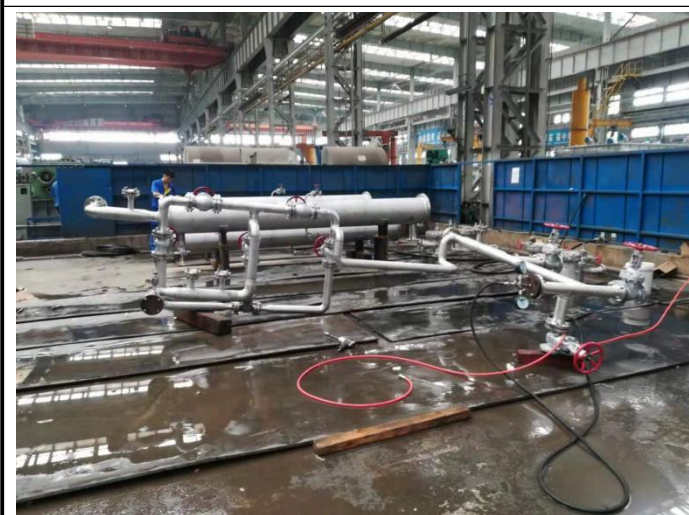
7.The hydrostatic pressure test for piping of Regeneration Gas Compressor of product no ***

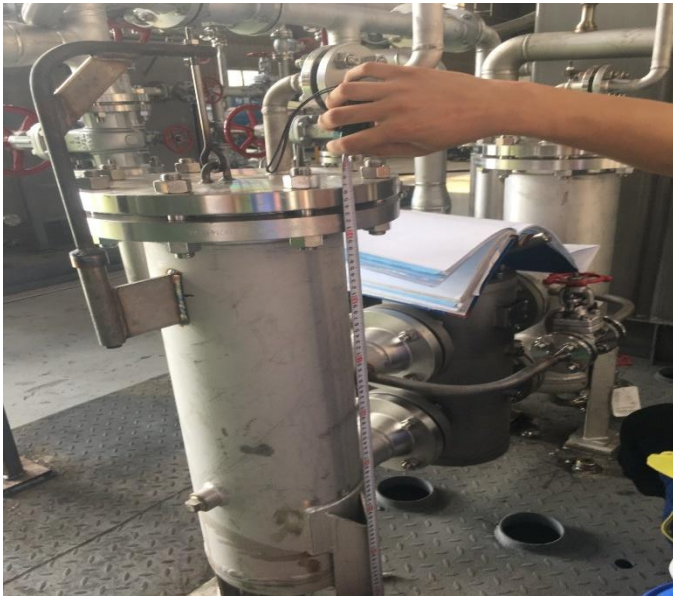
The shell adopts 216 seamless pipe. The welding height of the legs, the flange from the foundation to the shell is 932mm (Drawing design value: 932mm).

11. Measure the shell height of oil filter for Regeneration Gas Compressor of product no ***

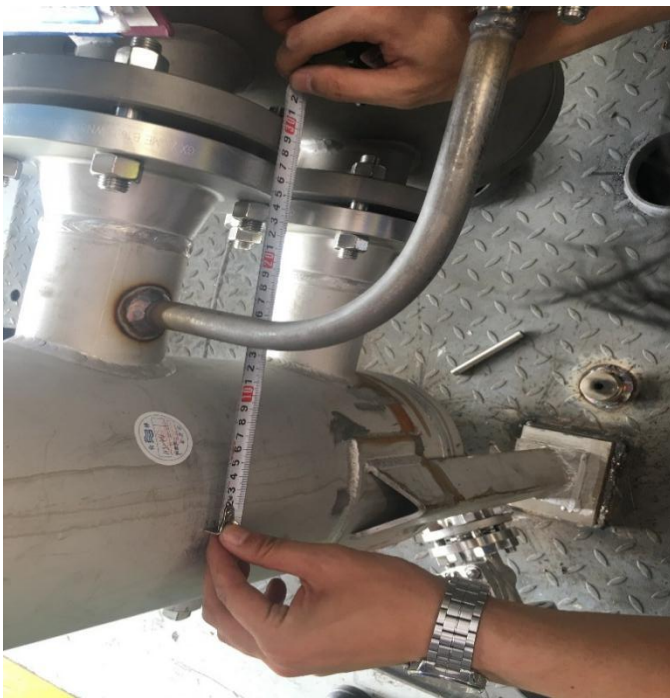
The flange size from the shell to the change-over valve is 270mm (Drawing design value: 270mm), etc.

13. Measurement of flange dimension from shell to change over valve (product no ***)

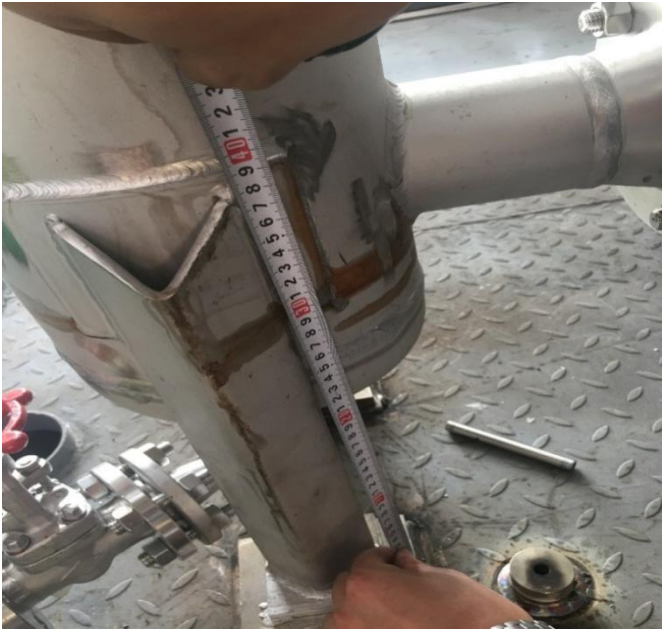
15. Height measurement of oil filter feet(product no ***)

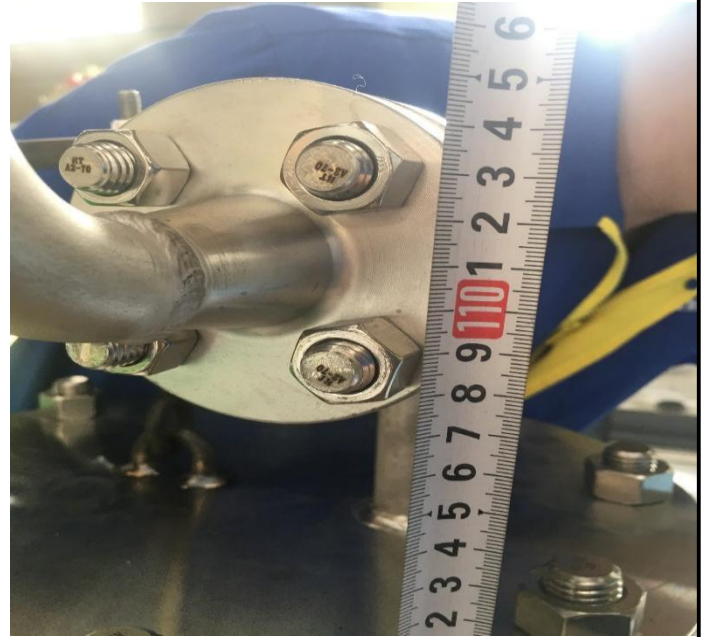
The flange from the foundation to the top edge of the connecting pipe flange of the cover plate is 1124mm (Drawing design value: 1124mm).

16. Dimension measurement of connecting pipe flange from oil filter foot to gland(product no ***)

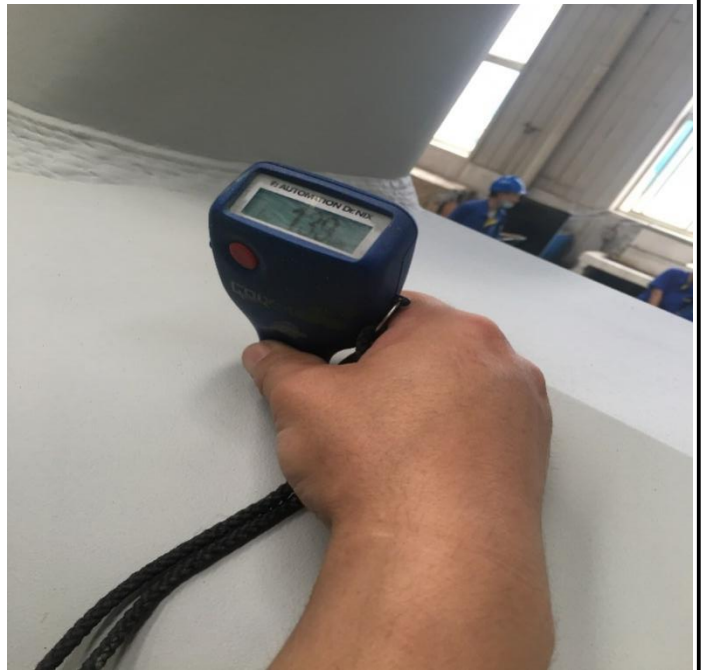
10.5.2.4 The thickness of the paint film on the casing and base of the compressor (***/***) was measured by using the paint film thickness gauge. The thickness range basically meets the requirements of ***;

18. Inspection of paint thickness of compressor casing (product no ***)

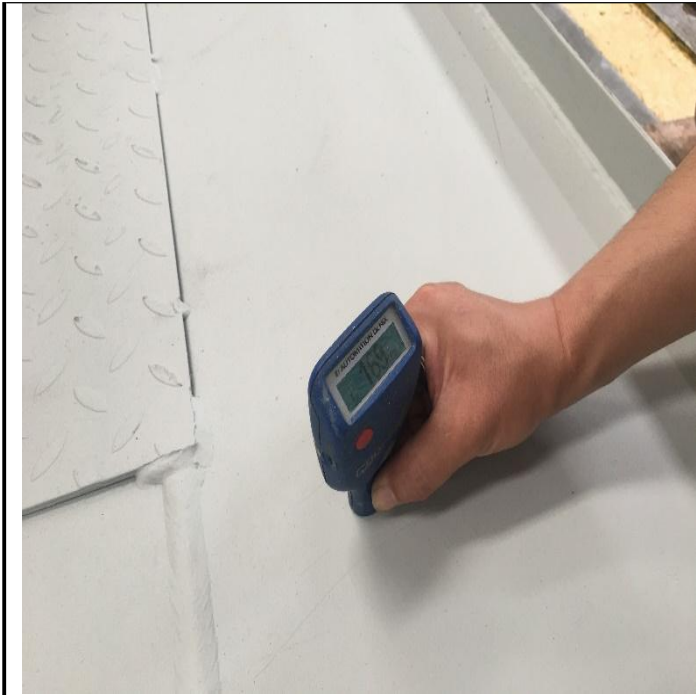
19. Inspection of paint thickness of base plate(product no ***)

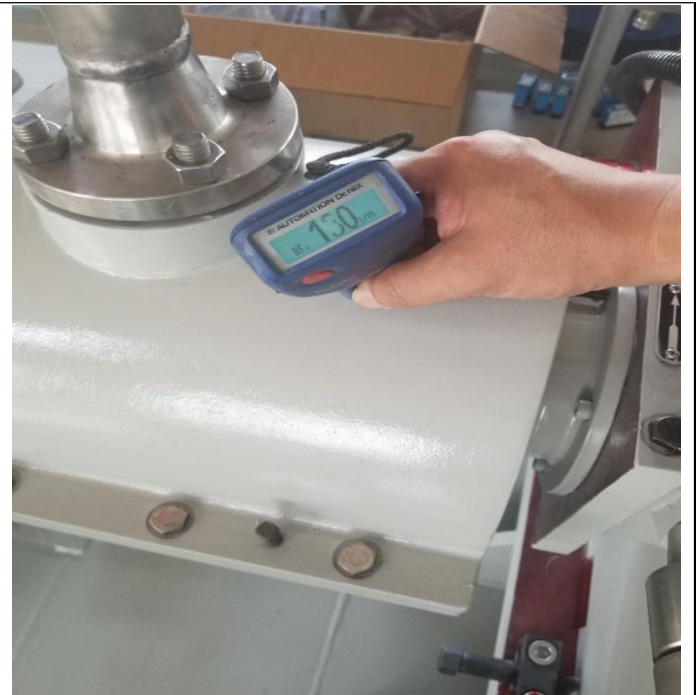
Note 5: The thickness of the paint film on coupling cover is not thick enough and needs to be repainted. The require value is 200~250μm. The actual value is 130μm. The details refer to photo 20 and below:

20. The thickness of the paint film on coupling cover is not thick enough and needs to be repainted(product no ***)

The thickness range basically meets the requirements of ***.10.1after repaint; The details refer to photo 49/50. So the note is closed.

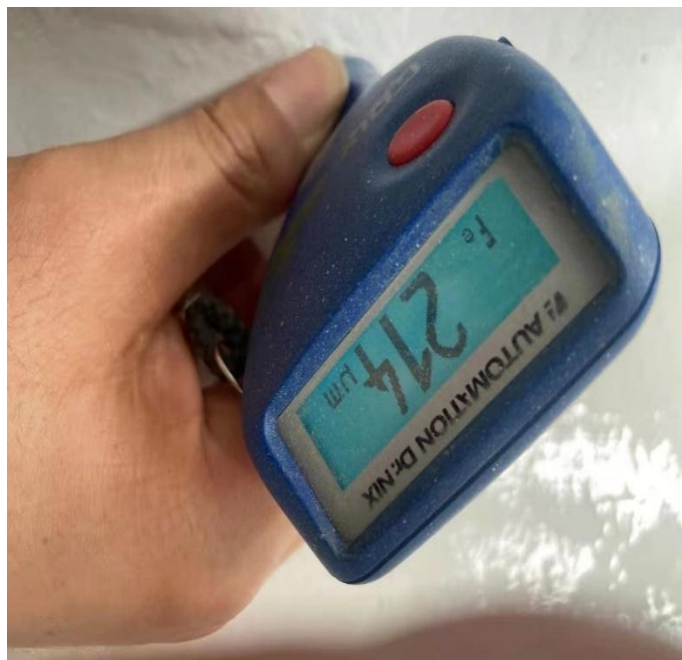
Note 10: The upper limit of diaphragm film thickness for ***/*** slightly exceeds the standard of painting procedure for item 10.2. The details refer to photo 36.

36. Film thickness measurement of *** / *** diaphragm

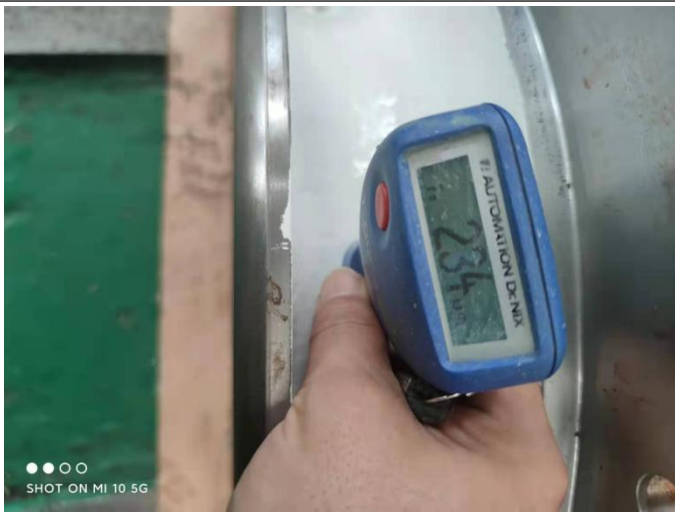
The upper limit of diaphragm film thickness for ***/*** slightly exceeds the standard of item 10.2. The details refer to photo 45, 46.

45. Film thickness measurement of *** / ***
diaphragm

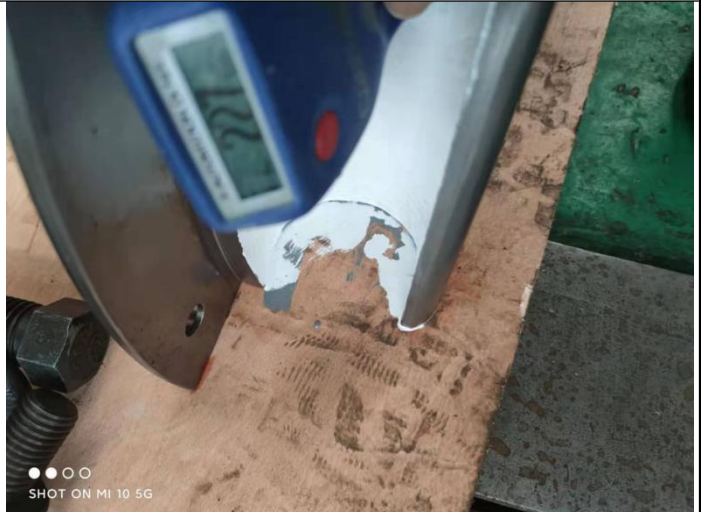
46. Film thickness measurement of *** / ***diaphragm

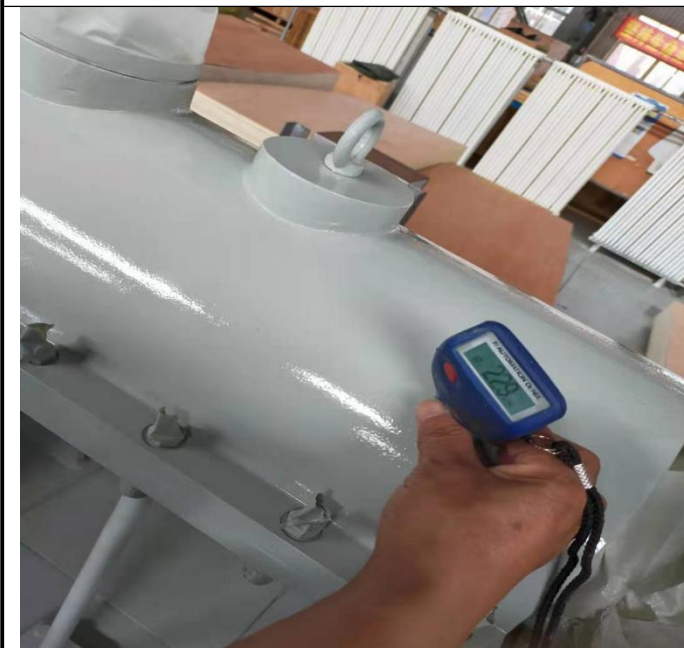
49. Film thickness measurement of *** coupling cover after repainting

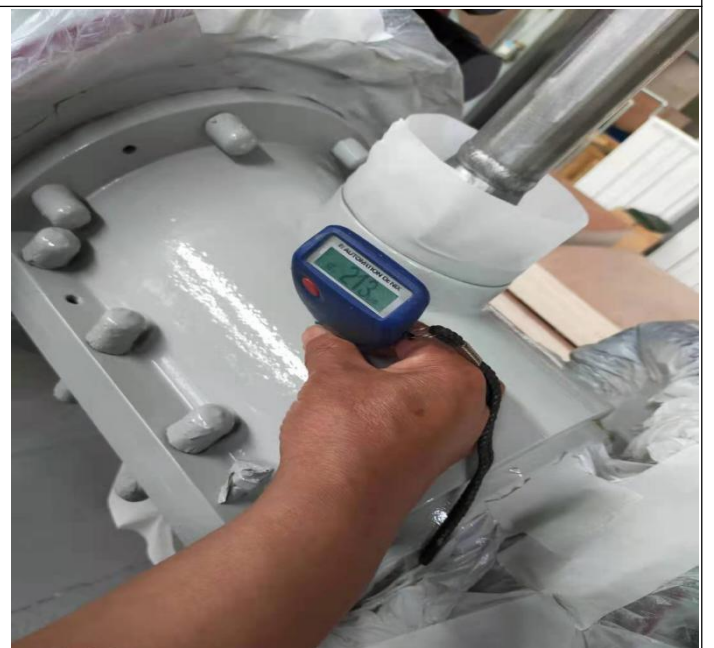
50. Film thickness measurement of *** coupling cover after repainting
